Manhole Inspection Summary

Manhole # S51K__016MH

Insp Date: 9/11/08 9:59 AM

Location Address: **side 2825 fait av**

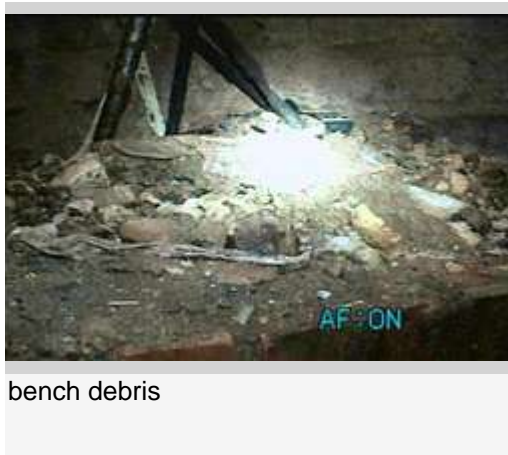
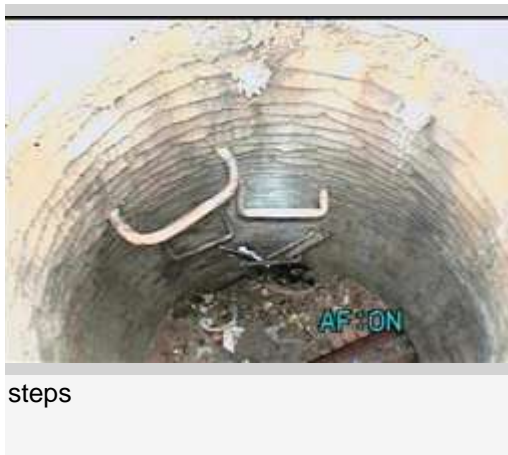
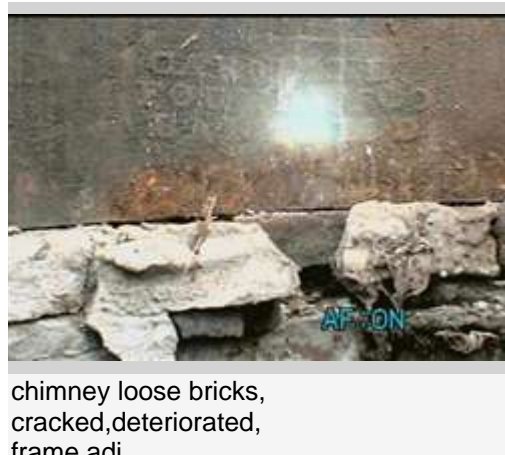
Condition: ☐ Sound ☒ **Cracked** ☐ Root Intrusion ☒ **Loose Brick** ☒ **Deteriorated**

chimney loose bricks,
cracked,deteriorated,
frame adj

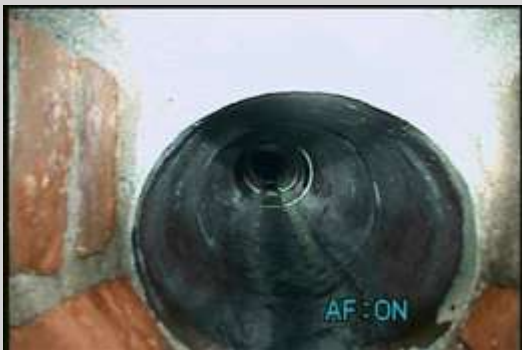
12 O'Clock Outflow

8 in. Circular Gravity Sewer
Pipe Out @ 12 O'Clock

Invert Depth: **9.60** (ft.) Flow Characteristics: **Fast**

Infiltration: **None** Pipe Seal Cond: **Unknown**

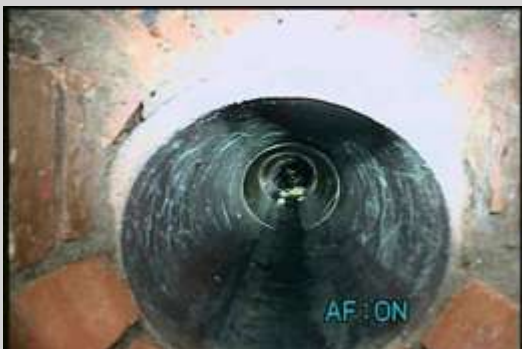
9 O'Clock Inflow

8 in. Circular Gravity Sewer
Pipe In @ 9 O'Clock

Invert Depth: **9.50** (ft.) Flow Characteristics: **Fast**

Infiltration: **None** Pipe Seal Cond: **Unknown**
